# Effect of Surface Defects on FRP-Concrete Interface Bond Strength

Nur Yazdani<sup>1</sup>, Mina W. Riad<sup>2</sup>, Romy Salloum<sup>3</sup>, Rebecca B. Carr<sup>4</sup>

Carbon Fiber Reinforced Polymer (CFRP) laminates have been successfully used as externally bonded reinforcements for retrofitting, strengthening and confinement of concrete structures. The adequacy of the CFRP-concrete bonding largely depends on the bond quality and integrity. The bond quality may be compromised during the CFRP installation process due to various factors. In this study, the effect of four such construction-related factors were assessed through various laboratory destructive testing methods, and quantification of any detrimental effects was achieved. The factors were: surface voids, surface wetness, upward vs. downward CFRP application, and surface cleanliness. A common unidirectional CFRP was applied to small scale flexural concrete samples with induced surface defects. Schmidt Hammer, pull-off testing and flexural testing were employed to determine possible detrimental effect of the induced parameters on the bond quality and flexural failure load. The Schmidt Hammer approach was found to be i

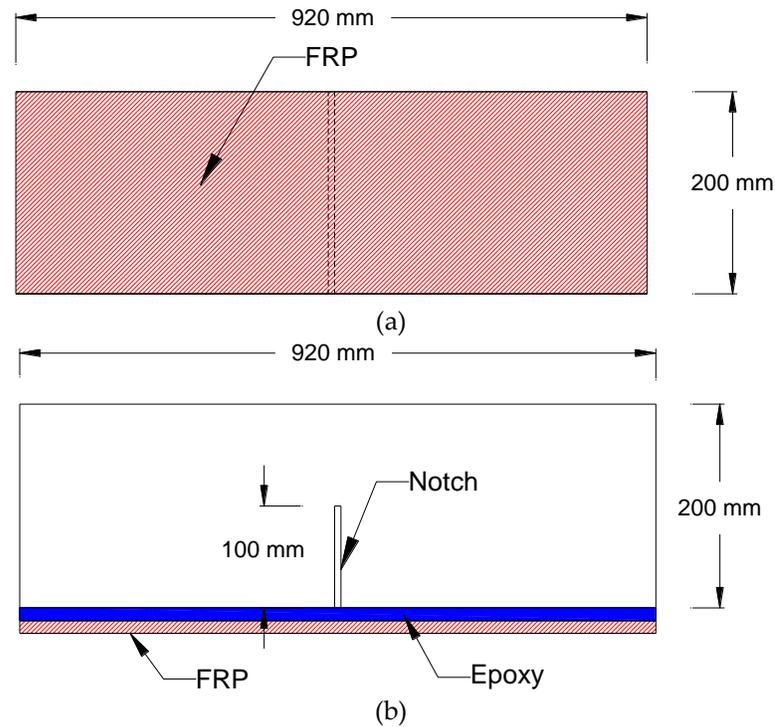
**Figure 1.** Sample Dimensions. (a) Plan; (b) Elevation

Figures 1 and 2 show the dimensions and the finished beam samples, respectively.

The width of each beam was chosen as 200 mm in order to accommodate the GPR antenna size, while the depth and length were selected following ACI 440 [18] guidelines to make sure that the load testing failure occurred in the FRP concrete interface. As the capacity of the bond is directly proportional to the concrete strength, the design was based on a concrete compressive strength ( $f'_c$ ) of 24.1 MPa. The failure load for the control beams was calculated as 62.2 KN, which was below the capacity of the available bending test machine. This helped in achieving a balance between a typical concrete strength and a beam size and load carrying capacity, that were handled well in testing. Equation 1 from ACI 440 [13] was used to calculate the strain level at which debonding may occur. The beam was sized to reach strain values that exceeded the ACI 440 strain limit.

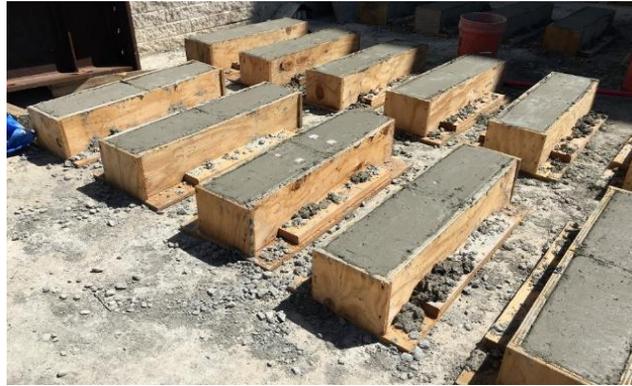
**Figure 2.** Concrete Beam Specimens

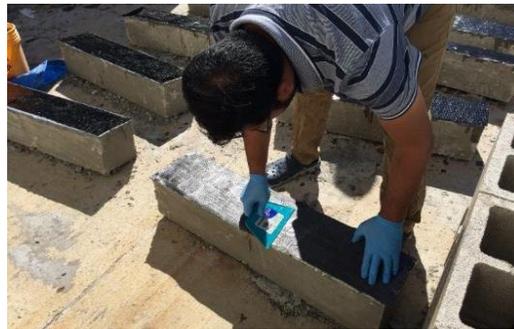
**Figure 3.** Application of CFRP laminate

A common unidirectional CFRP laminate was applied at an ambient temperature of 16°C, in the absence of direct sunlight, to prevent any undesirable problems with the epoxy. The one-layer CFRP application completely covered one horizontal face of each sample, simulating flexural strengthening in a beam type member. The manufacturer specified values for the CFRP laminate are presented in Table 2. Figure 3 shows the application process of CFRP laminate.

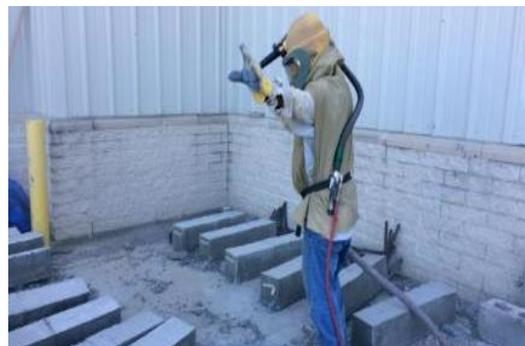
**Figure 4.** Sand Blasting of Beams

The study involved a parametric combination and two sample replications for each parameter, as shown in Table 5. As stated in ACI 440 [13], the concrete surface was roughened by sandblasting to a CSP3 profile [**Error! Reference source not found.**] to facilitate good quality CFRP bonding, as shown in Figure 4.

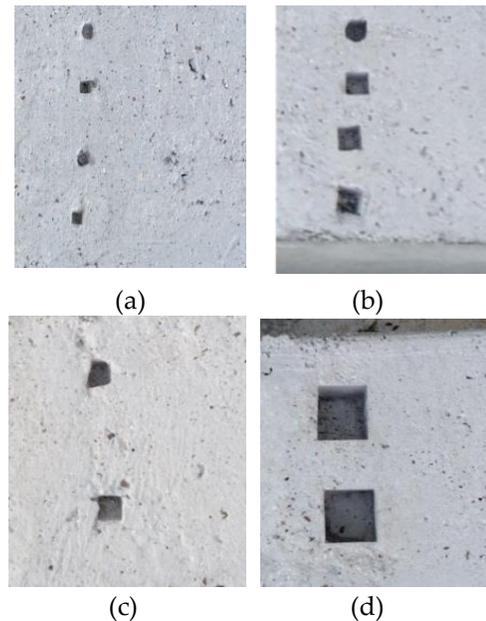
**Figure 5.** Surface Voids. (c) Sample 3 (10 mm voids); (d) Sample 4 (20 mm voids); (c) Sample 5 (20 mm voids); (d) Sample 6 (30 mm voids)

To investigate the effect of air voids under the CFRP, a few small to large surface voids were placed on the fresh concrete for samples 3 - 6 using foam cubes (Figure 6). The void dimensions were selected to result in possible decrease in bond areas. The allowable void size under CFRP, according to ACI 440.2R [**Error! Reference source not found.**], is less than 1300 mm<sup>2</sup> each. The void sizes were 10 x 10 x 10, 20 x 20 x 20, and 30 x 30 x 30 mm, respectively. No voids were planted on the surfaces of the remaining samples.

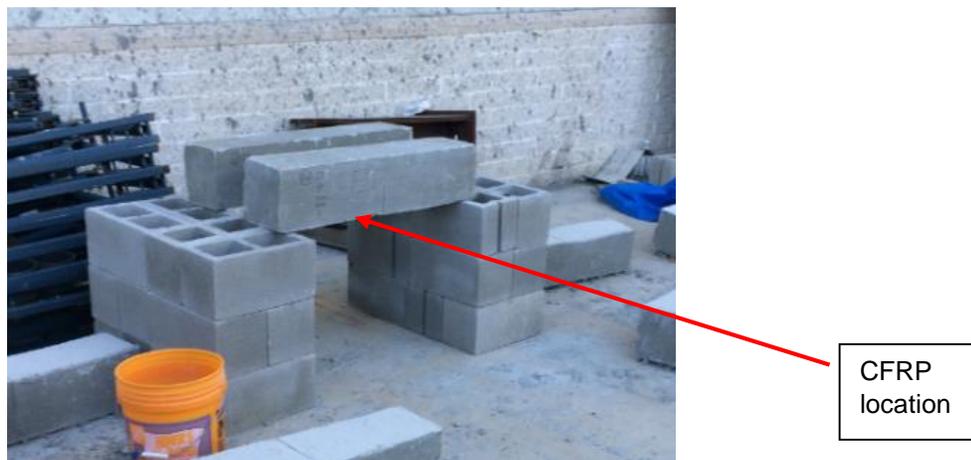
**Figure 6.** Setup for Upward application of CFRP

Samples 9 and 10 were supported on both ends, allowing access below the samples, as shown in Figure 5. The CFRP was then applied from below as an upward application, typical for application on the bottom flange of girders and underneath of slabs. For the other samples, the CFRP was applied from the top, as shown in Figure 3. A combination of types 1 and 2 epoxy were used herein, as discussed earlier.

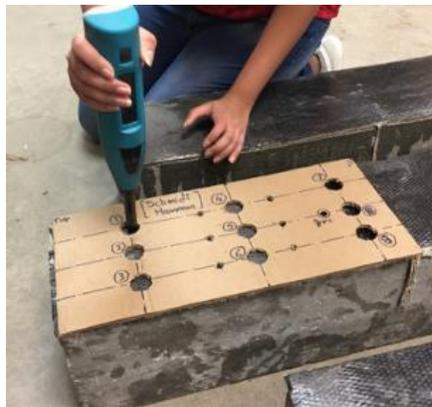
Figure 7. Schmidt Hammer Test

This is a widely used testing equipment for estimation of concrete, asphalt and rock strengths. Although it is considered non-destructive, in reality it is partially destructive when used on CFRP retrofitted beams, as it ruptures the CFRP fibers. The test was done according to ASTM C805 standards as mentioned in the ACI 440.2R-17 guidelines. The test using the hammer can be seen in Figure 7 below.

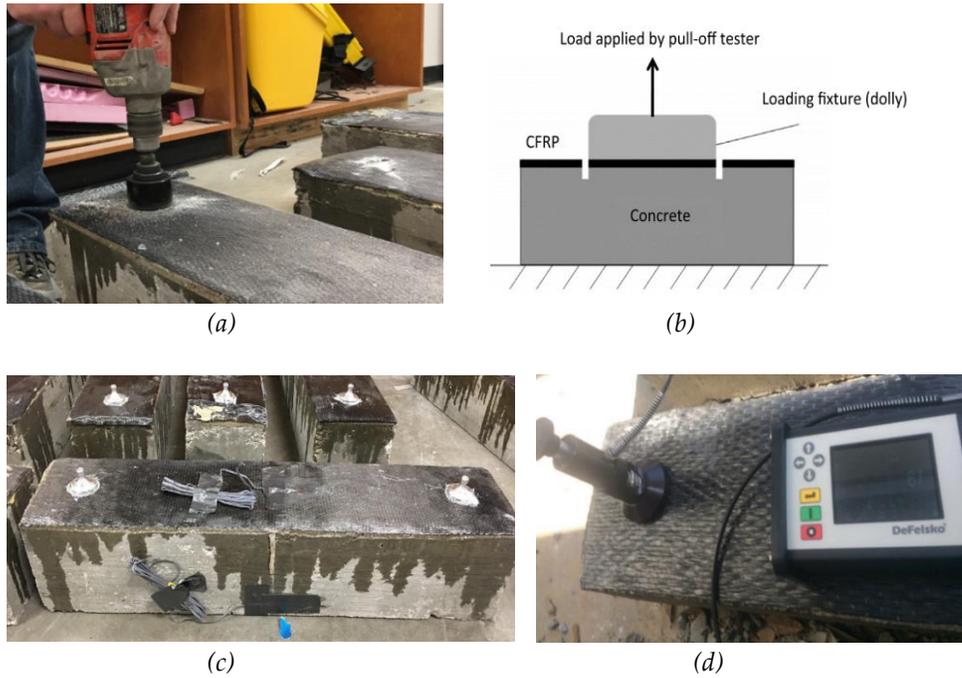
Figure 8. Pull-Off Testing. (a) Attached Dollies; (b) Mechanism; (c) Scoring; (d) Testing in Progress

The ASTM Pull-Off Testing was performed to spot check the tensile pull-off strength of the CFRP laminate with 50 mm wide dollies glued to the laminate. The maximum pull-off pressure and pull rate was recorded at two locations, 75 mm from the sample edge on each side.

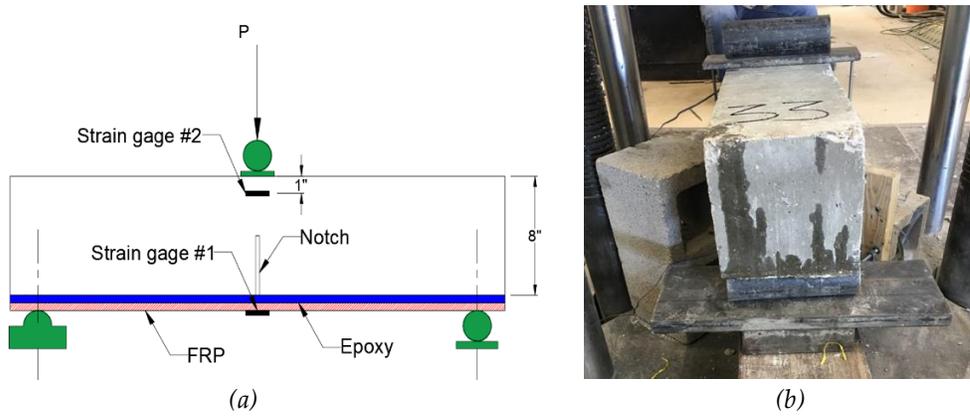
Figure 9. Three-point Bending Test Setup. (a) Schematic; (b) Actual Testing

A three-point flexural testing protocol was adopted herein to determine the failure load of all beam samples in order to investigate any effect of the surface defects on the flexural capacity (Figure 9). All supports were made of thick steel plates to prevent deflection at the supports. A 2670 kN compression testing machine was used under a constant rate of loading. The built-in notch ensured that the failure was at the mid-span. Data was collected from a linear varying displacement transducer (LVDT) at mid-span for deflection, and two strain gages, as shown.

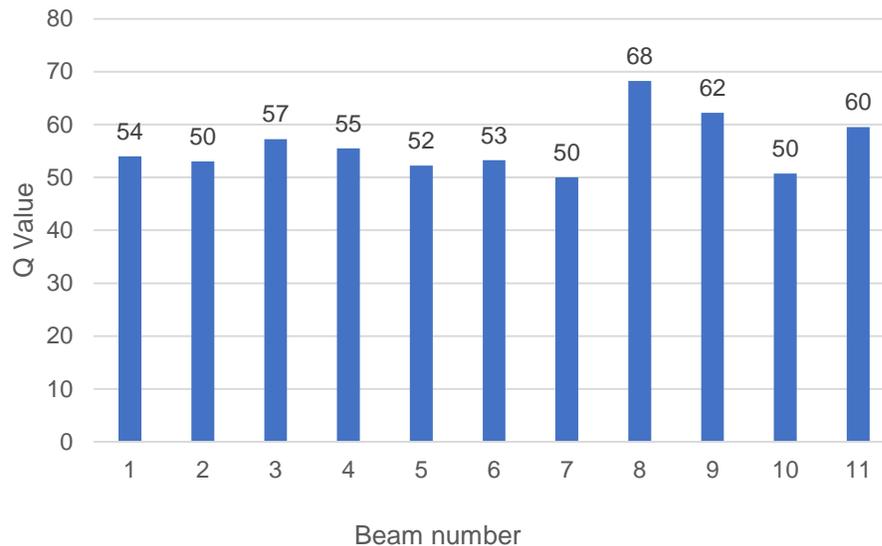
Figure 10. Schmidt Hammer Rebound Q Values

For the Schmidt Hammer approach, the ratio between the rebound velocity and the impact velocity is designated as the “Q” value, and the averages obtained herein are shown in Figure 10.

The results were found to be somewhat inconsistent. For example, Q values for control samples 1 and 2 were less than that in most other samples. These samples had no induced surface defects, and should have the highest hardness values of all samples. Samples 7 and 8 had the same parameter of surface wetness, but the Q values for the tow samples were quite different (50 and 68.5, respectively). Similar inconsistent observations may be made for samples 9 and 10. Possible cause of this inconsistency could be the partial rupture of the CFRP due to the Hammer impact in most samples. This rupture arbitrarily varied between samples. It may be inferred that Schmidt Hammer is not a reliable tool for hardness measurements on CFRP laminates applied on concrete surfaces.

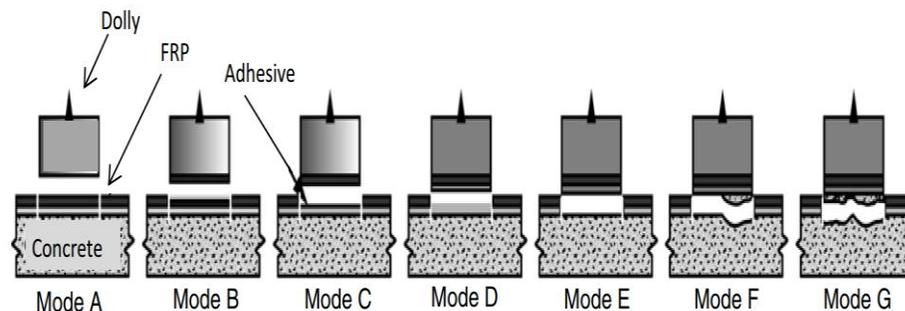
Figure 11. Pull-Off Test Modes of Failure (ASTM D7522/D7522M) (© 2009)

The efficacy of the CFRP- Concrete bond can be determined by inspecting the failure modes from the ASTM pull-off testing. Conceptually possible failure modes are shown in Figure 11. The desired mode is type G, indicating that the bond is adequate and the failure is entirely in the concrete substrate. Mode D is a cohesive failure in the epoxy joint, while Mode F is a mixed cohesive failure in concrete and epoxy at the epoxy/concrete interface. These last two modes may be due to inconsistent FRP-concrete adhesion, and could be caused by the presence of surface defects or gravity effect on CFRP. The average pull-off strengths found herein are shown in Table 8.

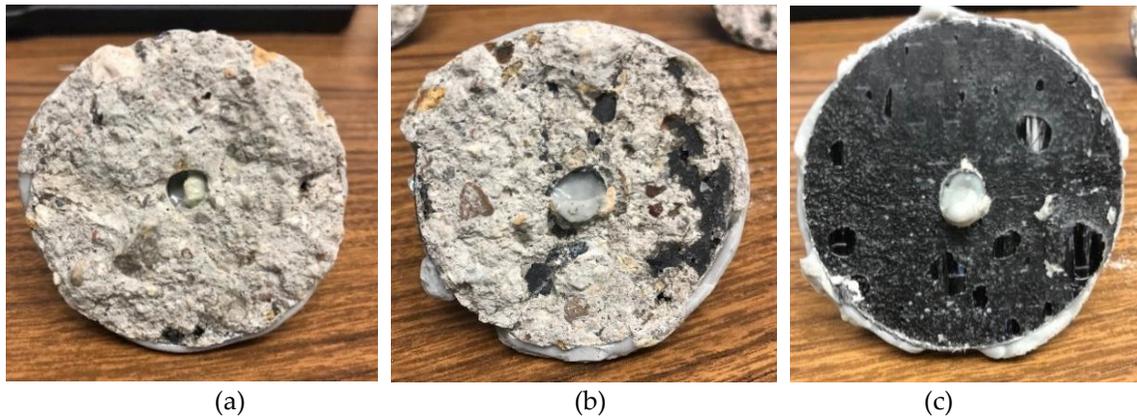
**Figure 12.** Pull-off Test Sample Failures. (a) Sample 2, Mode G; (b) Sample 9, Mode F; (c) Sample 8, Mode C

It is apparent from Table 6 that most pull-off test samples performed relatively well with Mode F – G failures. For samples 3 to 6, the presence of voids did not affect the pull-off results because the dolly was attached to FRP locations that avoided the voided areas. Sample 8 with wet surface had a Mode C failure with lower pull-off strength as expected. Samples with overhead FRP application and unclean surface experienced Mode F failure with partial separation in the concrete substrate (next best to Mode G). Samples 1 – 6 had an average pull-off strength of 2.42 MPa, while the rest of the samples had average strength of 2.22 MPa. Therefore, the pull-off spot check showed the lower tensile strength (by about 9%) of the samples with induced defects (except the ones with voids). It may be noted that the pull-off test is a spot check of FRP bond quality and may not represent an overall indicator of the laminate bonding.

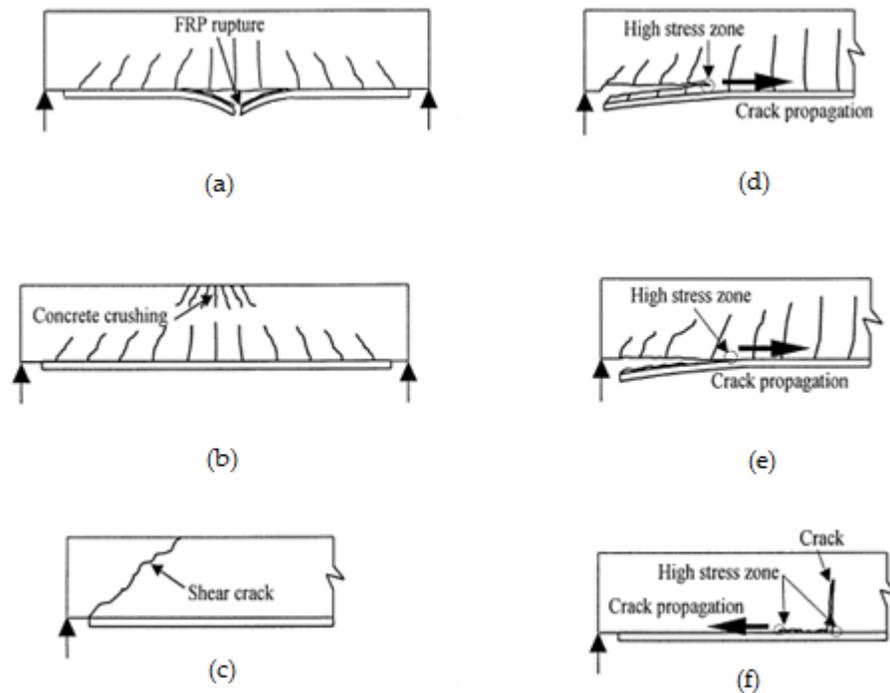
**Figure 13.** Failure modes in CFRP strengthened beams (Teng and Chen, 2007). (a) FRP Rupture; (b) Crushing of Compressive Concrete; (c) Shear Failure; (d) Concrete Cover Separation; (e) Plate End Interfacial Debonding; (f) Intermediate Crack Induced Interfacial Debonding

Various possible modes of failure for CFRP strengthened concrete beams are shown in Figure 12. If the CFRP laminate ends are properly anchored, failure occurs when the flexural capacity of the beam is reached, by either tensile rupture of the CFRP (Figure 8(a)) or crushing of concrete (Figure 8(b)). For either case, the steel reinforcement generally will not yield at failure.

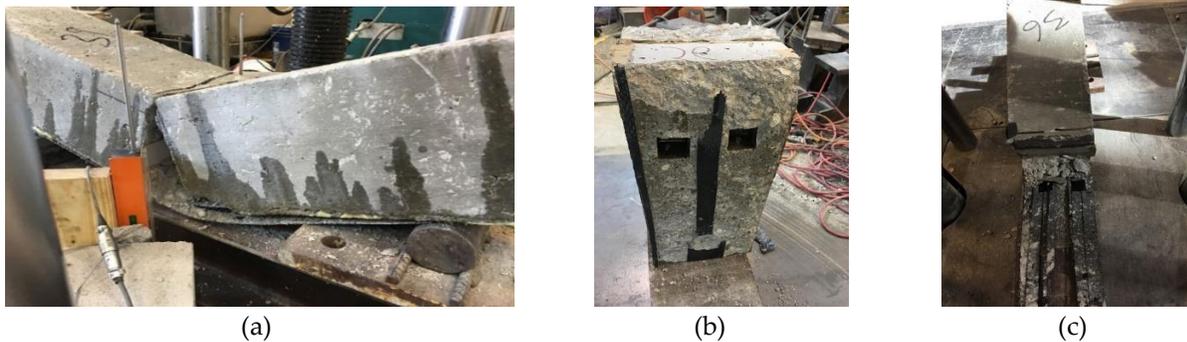
**Figure 14.** Intermediate crack induced interfacial debonding, Sample 7 (a) Failed Sample; (b) Bottom View; (c) Top View

The failure load and associated failure modes from the flexural testing of samples are presented in Table 2. A typical Mode f failure photographs are shown in Figure 11. The partial FRP debonding with some concrete attached is clearly visible.

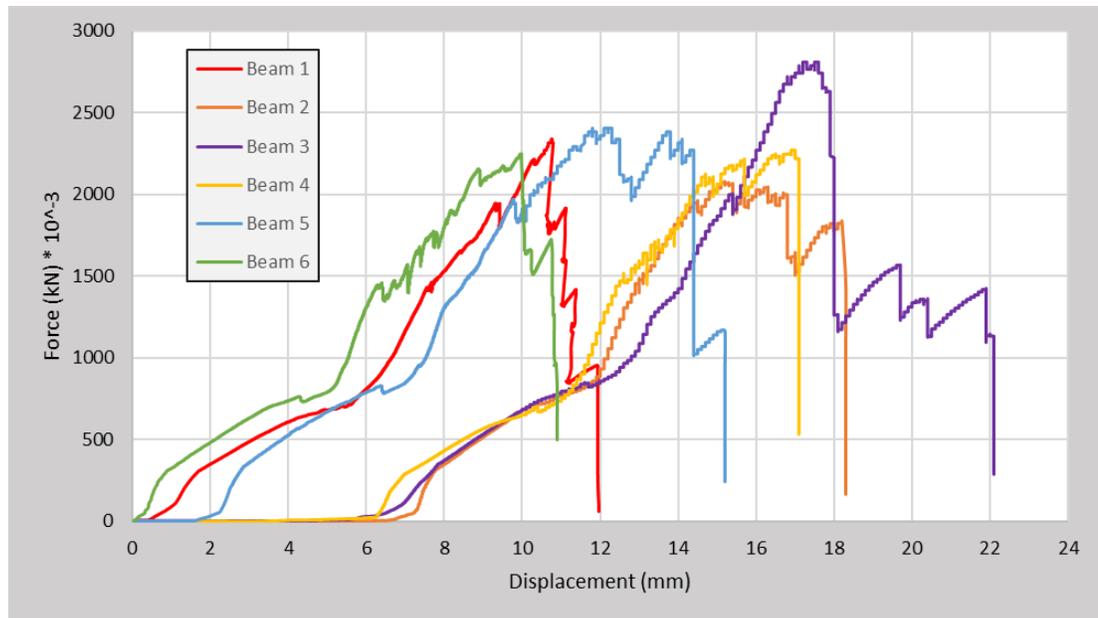
Figure 125. Load vs. Displacement Plots, Samples 1 – 6

Load vs. maximum deflection plots for all samples are shown in Figures 15 and 16. All graphs show a steep drop in load capacity after the CFRP debonding or cover delamination. It is apparent that all but two samples showed the undesirable plate interfacial debonding failure mode.

The plots show increased displacements at about 13.3 kN, possibly due to the initial engagement of the CFRP laminate in the flexural resistance process. Some samples showed a post-peak reserve strength behavior that included several short rises of load values after the peak performance with increased deflections.

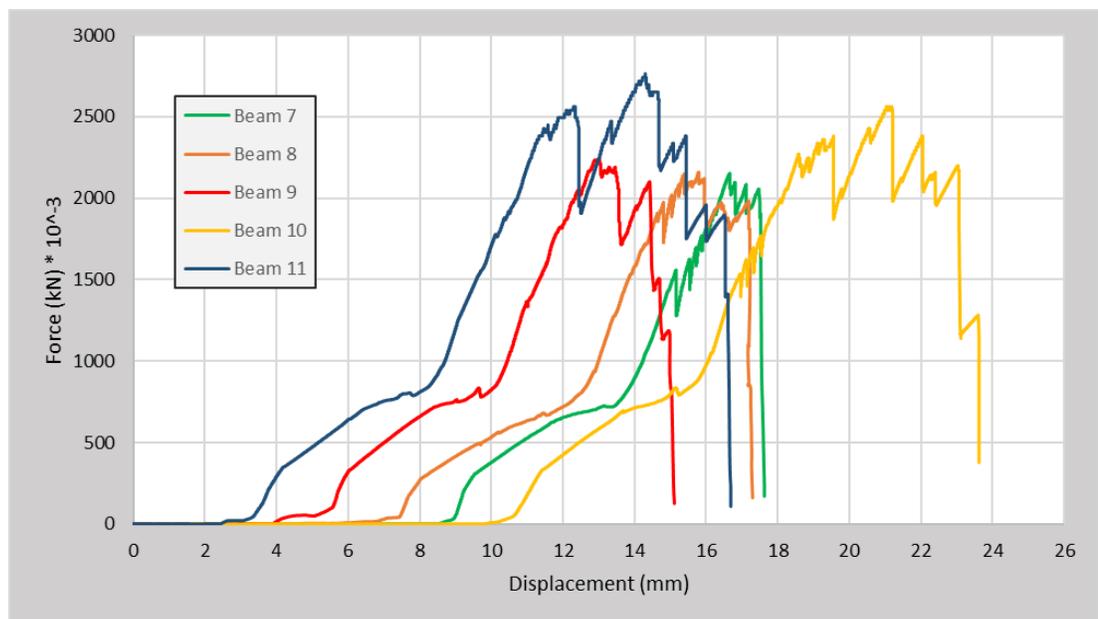
Figure 16. Load vs. Displacement Plots, Samples 7 - 11
